Manhole Inspection Summary

Manhole # S37S__014MH

Insp Date: **2/25/08 9:07 AM**

Location Address: **1248 williams st**

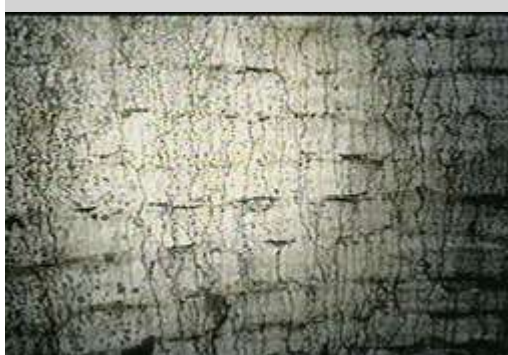
Defect 4

Infiltration: ☐ None ☐ Joint ☐ Cracks ☐ Mortar ☐ Roots ☒ **Wall**

infiltration in barrel

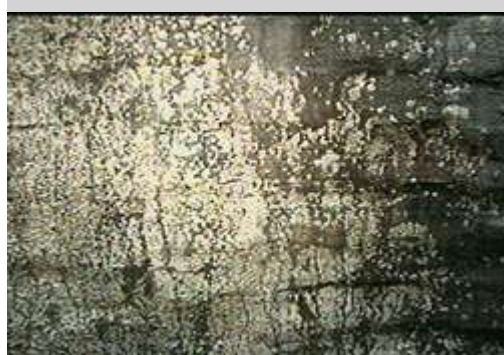
Defect 3

Infiltration: ☐ None ☐ Joint ☐ Cracks ☐ Mortar ☐ Roots ☒ **Wall**

infiltration in corbel wall

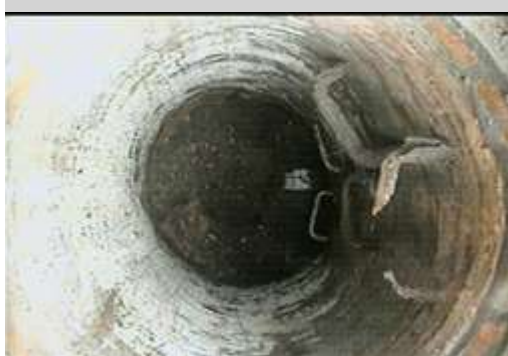
Defect 2

Condition: ☐ Sound ☐ Cracked ☐ Root Intrusion ☐ Deteriorated ☐ Leaks ☒ **Debris**

debris

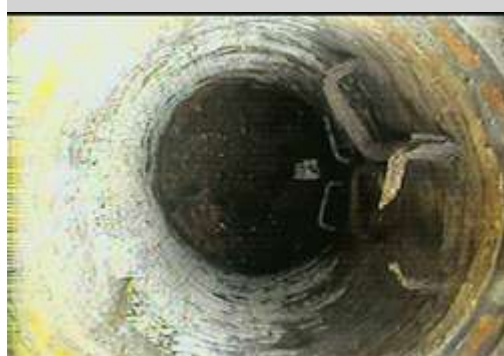
Defect 1

Count: **5** Missing: **1** ☒ **Corroded**

steps
